THE HANFORD SITE

PUREX Tunnel 2 photographs

July 2018

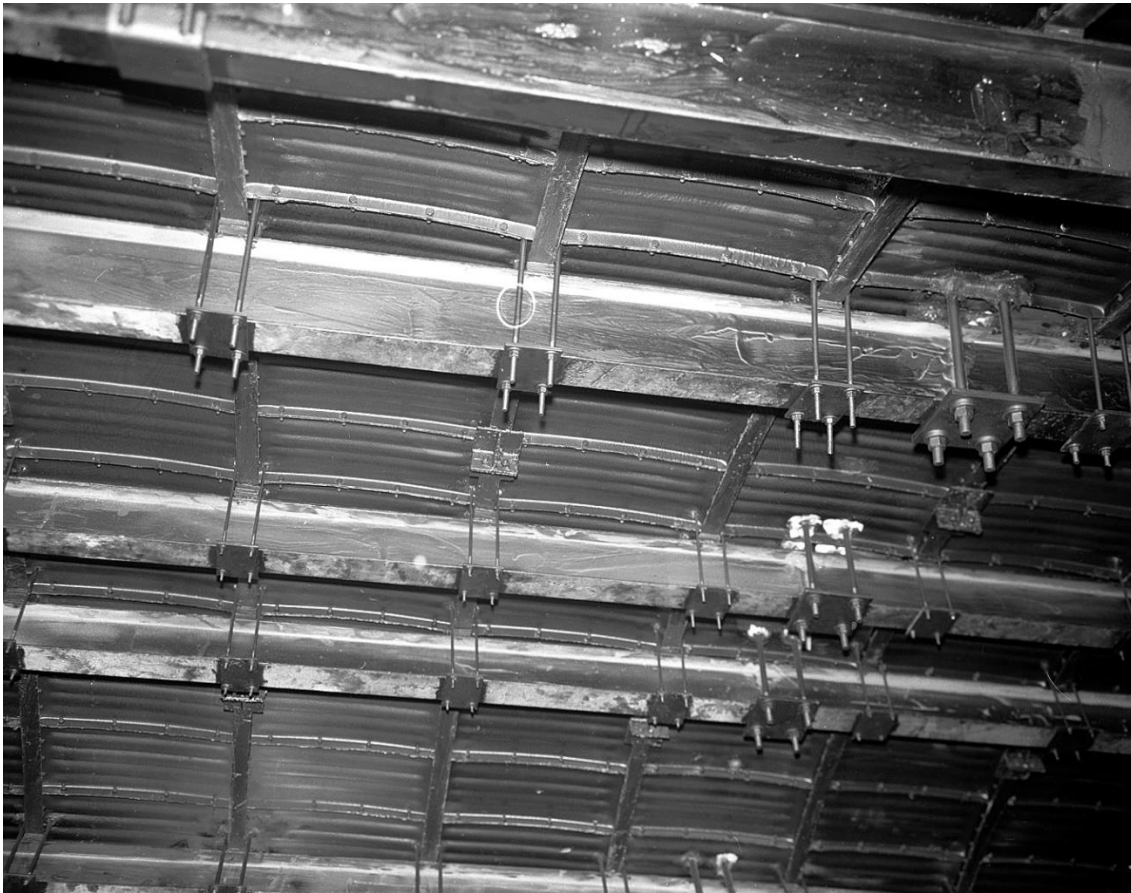
Observation of tunnel condition following construction

Photo of PUREX Tunnel 2 interior after construction was completed in 1964. The tunnel was built in the shape of a Quonset hut with a series of steel rib supports running perpendicular to the length of the tunnel. Corrugated steel roof panels are bolted to the supports. The roof was reinforced with additional steel supports.

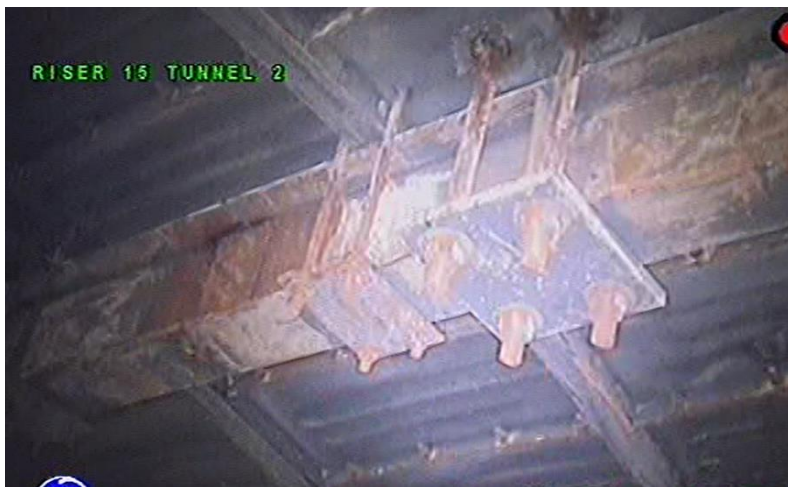
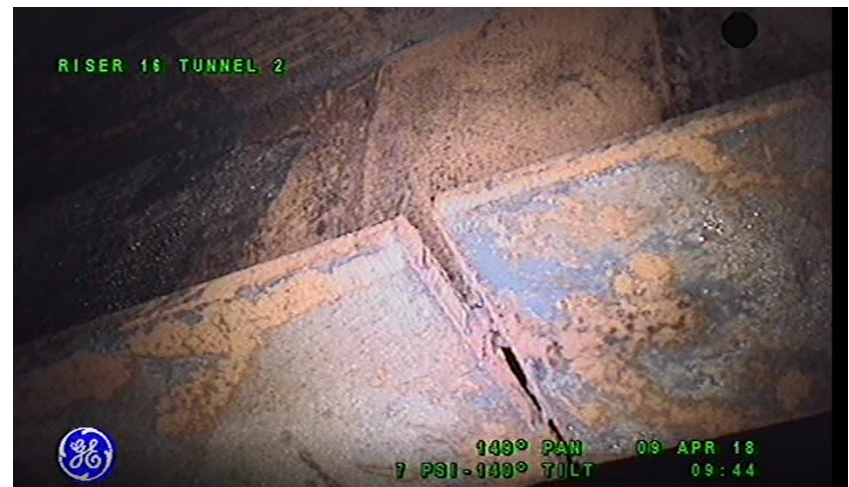
Still frames/photos from video inspection of PUREX Tunnel 2 in April 2018

To examine the condition of PUREX Tunnel 2 and confirm the tunnel was built according to construction drawings, video cameras were inserted through openings in the top of the tunnel in April 2018. These photos show corrosion of bolts, weld plates and bolt penetration locations. While not an indication of imminent collapse, the fact that some components are stressed above design capacity and are also corroding is a concern
